Appendix B

The Commonwealth of Massachusetts
Executive Office of Health and Human Services
Department of Public Health
Bureau of Environmental Health Assessment
250 Washington Street, Boston, MA 02108-4619

October 20, 2000

In December 1998, the Massachusetts Department of Public Health (MDPH), Bureau of Environmental Health Assessment (BEHA) issued a report detailing an indoor air quality assessment conducted at the First Barnstable District Court Route 6A, Barnstable Massachusetts. Of note was the condition of water-damaged books in the library, which were colonized by mold growth. As detailed in the assessment, the source of the moisture causing the mold colonization was theorized to be a vent located in the library storeroom (MDPH, 1998). This letter is an addendum to the 1998 Indoor Air Quality Assessment of the building.

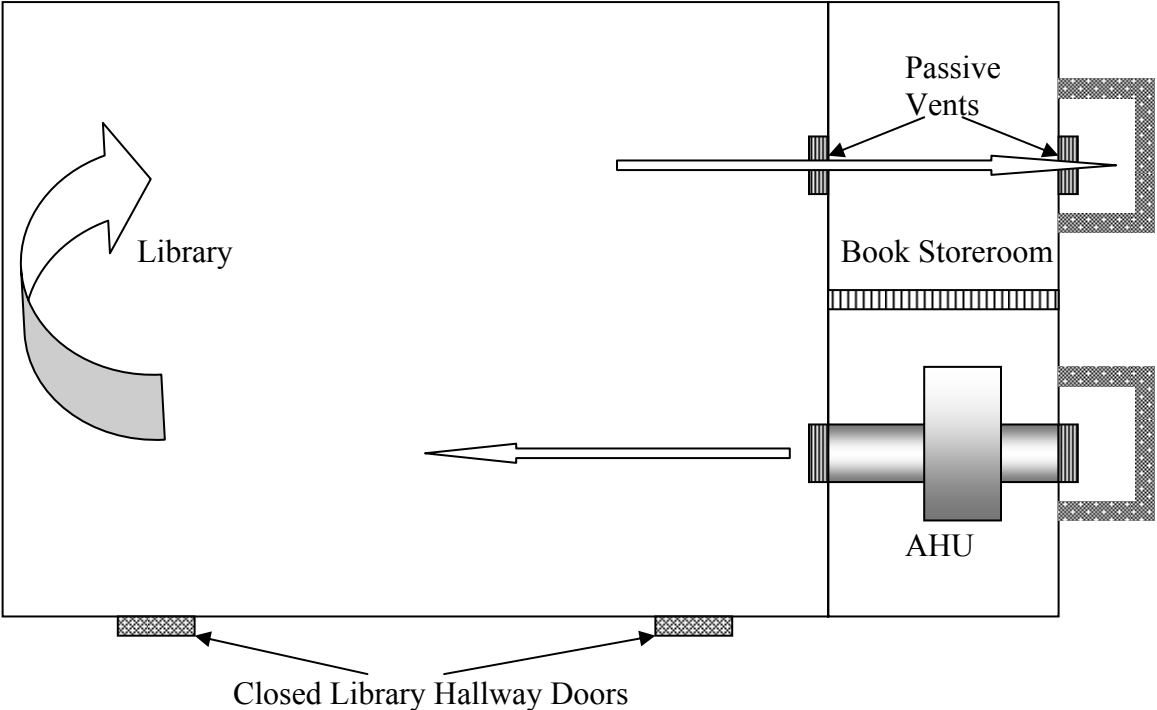
Figure 1 **Configuration of Library Ventilation System using Positive Pressure to Force Air from the Library out the Passive Vent System**

The design of these flaps serves several purposes. The ventilation system relies on positive pressure created by the (AHU) to force air out of the passive vent in the library/book storeroom wall (see Figure 1). As the AHU operates, air pressure increases as additional fresh air is introduced into the library (called positive pressure). As positive pressure increases, air is forced out of the main room of the library, through the wall vent of the book storeroom wall, and out the passive vent. The vent is designed to allow for the cloth flaps to open (see Picture 3) and slowly release air by positive pressure. The design of these exhaust vents requires that the library doors remain closed to the extent practical in order to maintain positive pressure. With hallway doors open, library air would be forced into hallways instead of out through the exhaust vent.

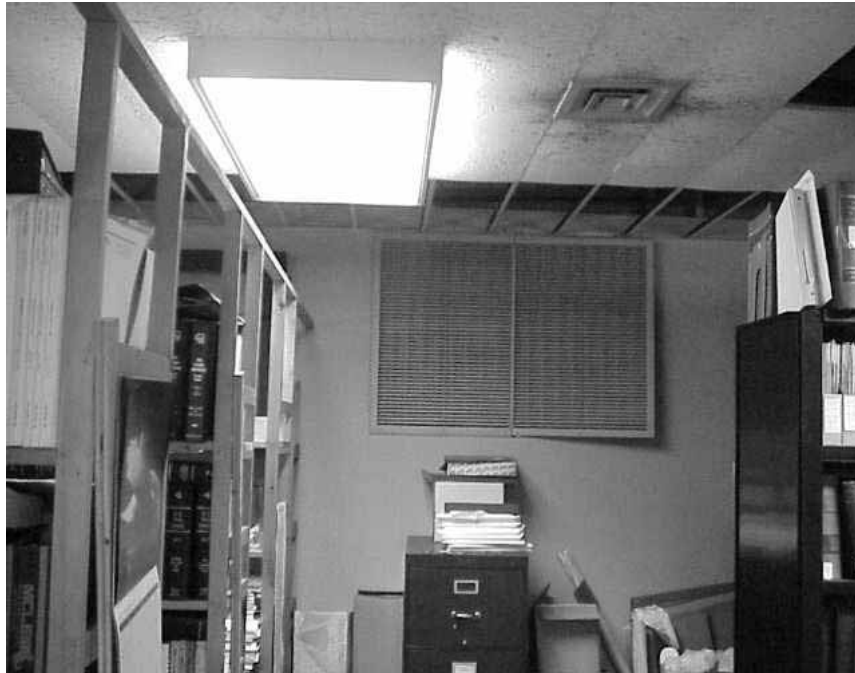
Picture 1

These conditions may indicate that an uncontrolled source of outdoor air is penetrating through the vents into the library and book storeroom. A closer examination of the library's ventilation system revealed a passive exhaust vent system that was part of the design of the building's ventilation system in the lower levels. In order to confirm the function of this vent (see Picture 1), the cover was removed. Behind the vent is a series of cloth flaps (see Picture 2).

Passive Vent in Book Storeroom

In order to avoid further damage to the book collection, a remedy to the moisture penetration needs to be implemented prior to any restoration. The most effective remedy is to replace the passive exhaust vent system with a mechanical system in both the library and victims aid office as referred to in our previous report (MDPH, 1998). The installation of a mechanical exhaust system in these areas would prevent water penetration through the passive vents and remove moisture introduced into the lower level by the normal operation of the air handling units.

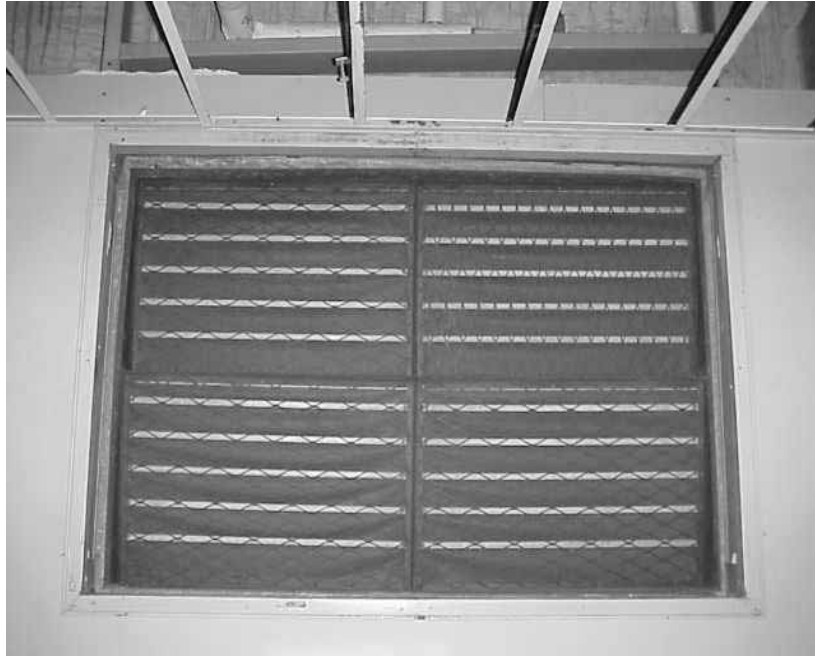
Picture 2

The problem with this system is that the vents are not airtight and can create backdrafting cold air, as noted by librarians. If cold air can backdraft, moisture can also penetrate into the book storeroom. Compounding the tendency of this vent to backdraft is its location several feet below ground level (see Picture 4). Even with adequate drainage, the walls and floor of the cement-lined pit where this vent exists will tend to retain moisture during periods of wet weather. The vent appears to be rusted along its top, which can indicate that rainwater is penetrating the frame. The presence of accumulated leaves on the floor of this pit promotes water damage and adds another potential source of microbial growth that may allow for penetration into the book storeroom.

Cloth Flaps of Passive Vent

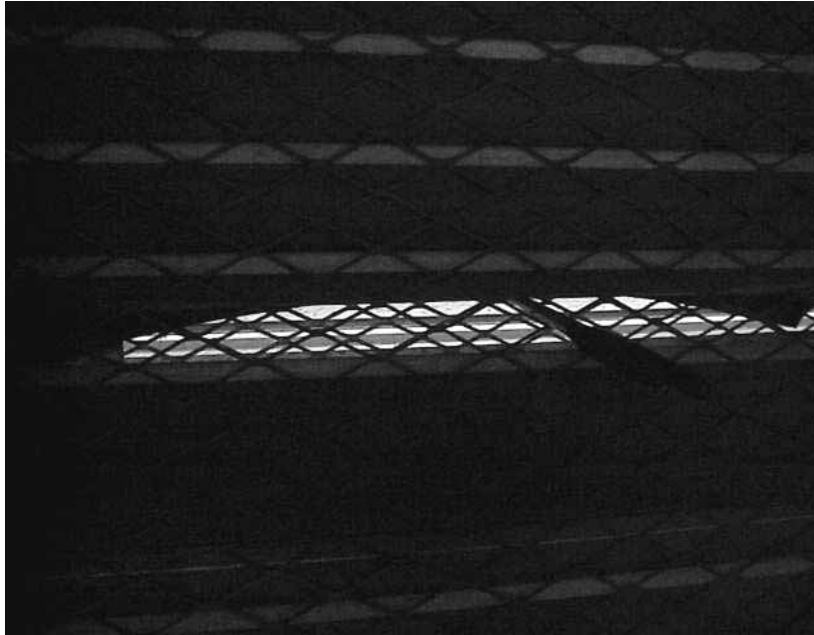
Picture 3

Vent With Cloth Flap Propped Open, Revealing Outdoor Light

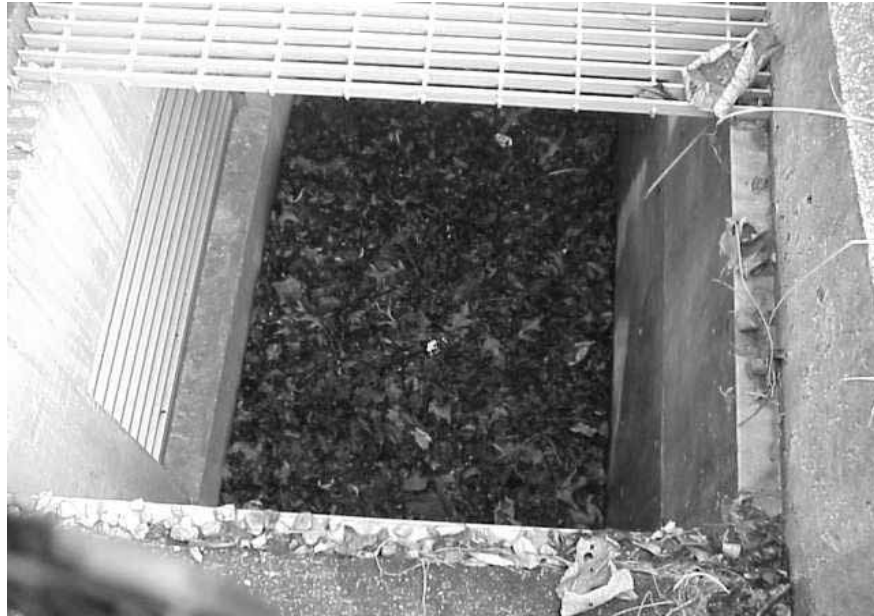
Picture 4

Floor Of Pit With Exterior Of Passive Vent, Note Wet Leaves On Floor Of Pit
